Fuel Leak Simulation

Dr. Michael R. Swain
University of Miami
Coral Cables, FL 33124

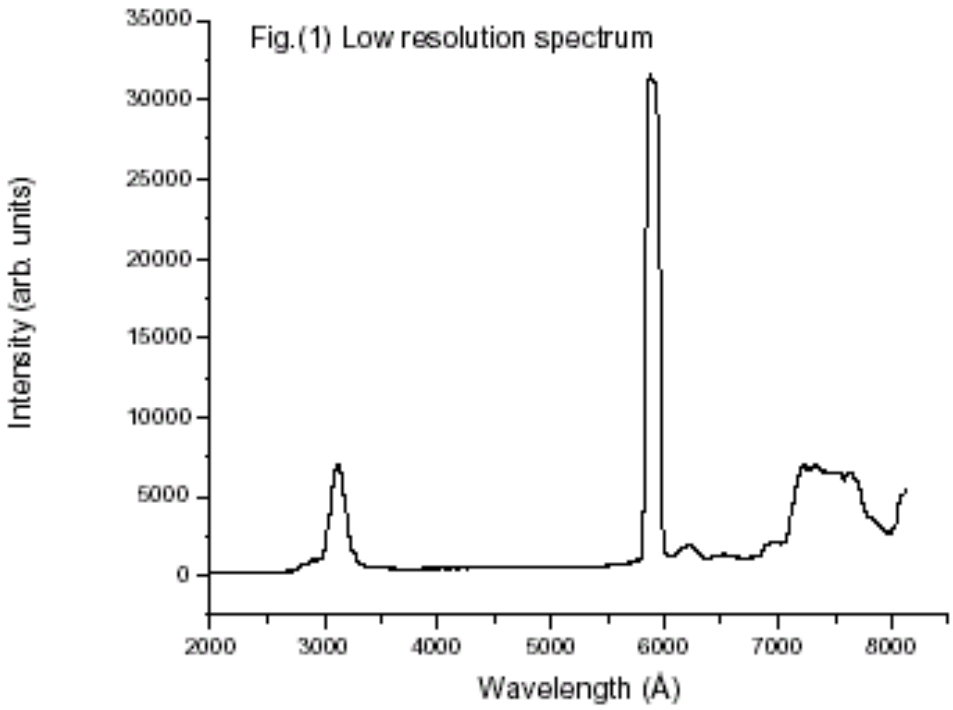
Figure (1) shows a typical low-resolution spectrum of the flame and is not corrected for the spectral response of the spectrograph and diode array. It is clear however, that three features dominate the spectrum:

1) a broad peak in the ultraviolet at ~ 3000 Å.
2) a narrow peak at ~ 5890 Å.
3) a broad peak in the near infrared between 7000-8000 Å.

There is an additional signal that lies above the background noise. Its integrated intensity is small compared with the main features and no clear spectral signature scan be identified at this spectral resolution.

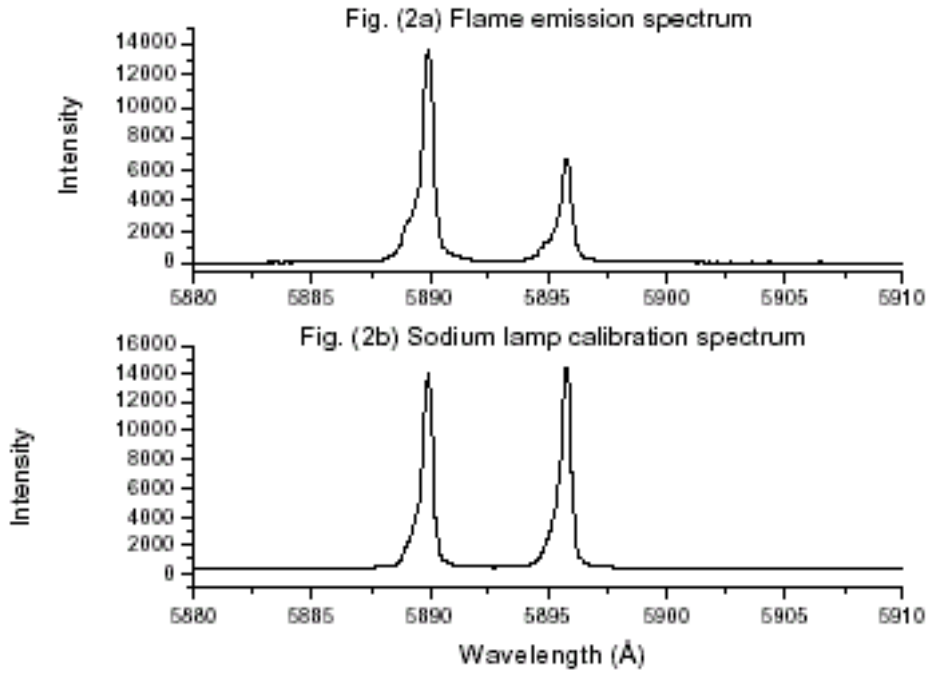
Figure (2a) shows a high-resolution spectrum of the 5890 Å feature taken with the 3/4 m spectrograph. Figure (2b) shows the spectrum of a high-pressure sodium lamp taken under identical conditions with the lamp in place of the flame. The high-resolution spectrum demonstrates unequivocally that the dominant flame emission is due to sodium D line emission. The characteristic D line doublet is due to emission from the excited ^2P state and consists of the D1 line due to the ($^2P_{1/2}$ - $^2S_{1/2}$) transition at 5895.93 Å and the D2 ($^2P_{3/2}$ - $^2S_{1/2}$) transition at 5889.96 Å.

These results demonstrate that the dominant spectral feature in the visible region of the spectrum is due to sodium D line emission. This is due to particulate matter containing sodium that is entrained into the flame. The results also demonstrate that we can obtain high-resolution spectra of the OH radical, which may serve as an important flame diagnostic particularly of flame temperature. If the sodium emission is due primarily to thermal excitation, then the brightness of the sodium D line emission will depend on the diffusion flame temperature.

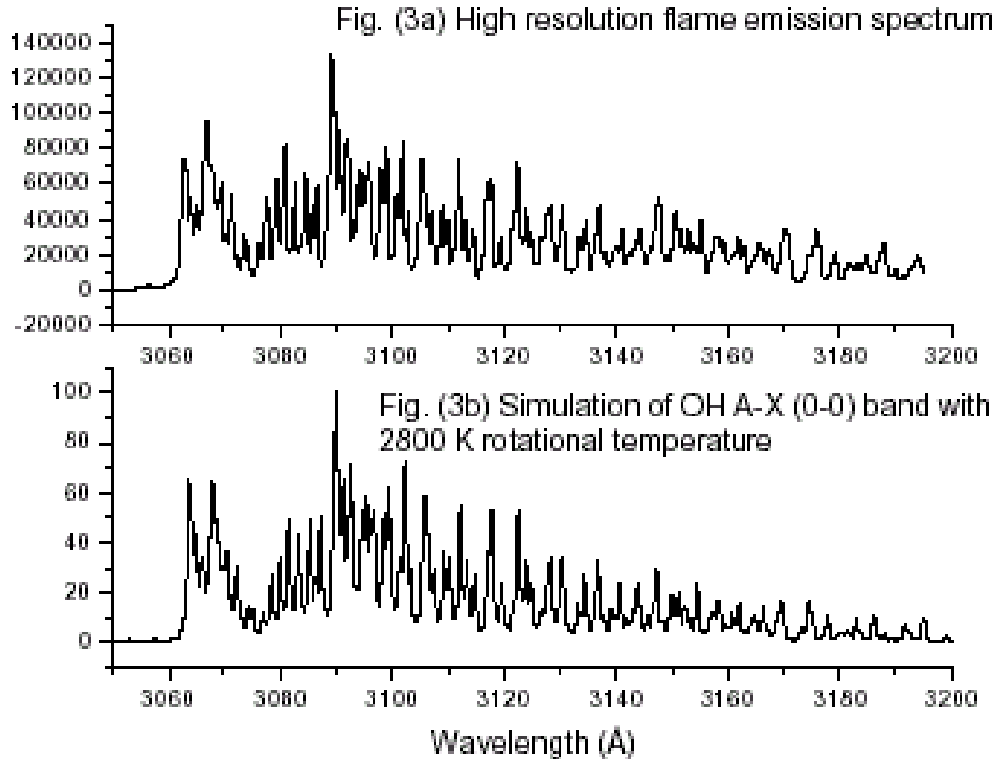
Figure (3a) shows a high-resolution spectrum of a portion of the 3000 Å feature. It can be seen that, in contrast to the sodium D lines we have a complex multi-line spectrum. This is characteristic of the spectrum of a simple diatomic or polyatomic molecule and the relatively open structure suggests a hydride. The strong emission spectrum of the OH A $^2\Sigma$-X ^2D (0-0) band lies in this region. This emission is characteristic of H_2/O_2 flames and has been extensively observed and characterized. A quantitative identification requires a computer simulation of the spectrum. Figure (3b) shows a simulation of the OH A-X (0-0) emission spectrum assuming a rotational temperature of 2800 K and a spectral resolution of 0.6 Å. The simulation clearly identifies the experimental feature as being due to OH. We have not attempted to identify the broad infrared spectral feature. Several sets of high and low-resolution spectra were obtained and this involved relighting the flame several times. It is an extremely turbulent diffusion flame
